INTRODUCTION

The present study documents the prosthetic complications, type and frequency, of ITI components that have occurred over 8 years of practice, all implants have been in function for at least 2 years.

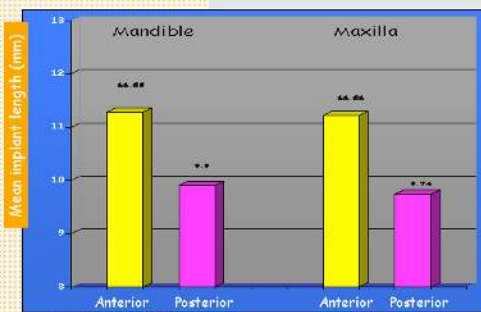
Fig 1 : Mean implant length by quadrant. Implants placed in the posterior region were short implants, mostly ≤ 10 mm.

Between 1995 and 2000, 528 implants rehabilitated 235 patients (mean 57.5 years). The mandible/maxilla implant distribution was 327/201. The mean implant length per quadrant is given in figure 1.

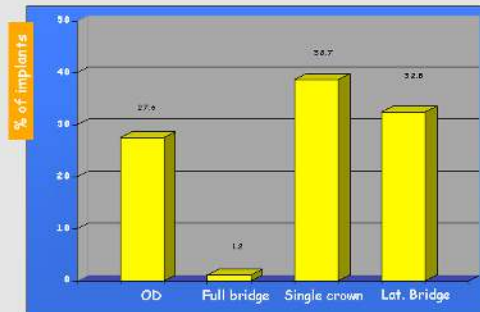
Fig 2 : Implant distribution by prostheses. Most implants supported fixed rehabilitations.

Implants supported single crowns (38.7 %), short-span 2 to 5-unit bridges supported by 2-3 implants (32.5 %), full-arch bridges (1.2 %) and overdentures (27.6 %) as shown in figure 2. Most implants (57.6 %) supported

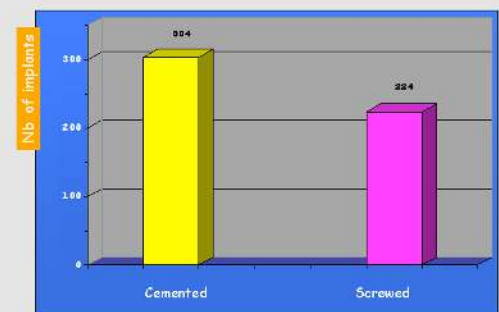
Fig 3 : Prosthesis fixation mode. Most suprastructures have been cemented.

cemented prosthesis (fig 3). Prosthetic complications included, abutment fracture, abutment loosening, prosthesis debonding, screw loosening and screw fracture.

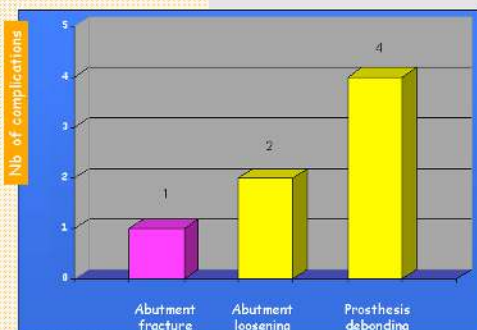
Fig 4 : Complication type and frequency. One abutment fracture was recorded. Abutment loosening led to prosthesis replacement.

One abutment fractured after 42 months (fig 4, 7), 2 abutments became loose after 8 and 10 months of function (fig 4), all supported single molar crowns. The abutments and the crowns had to be changed.

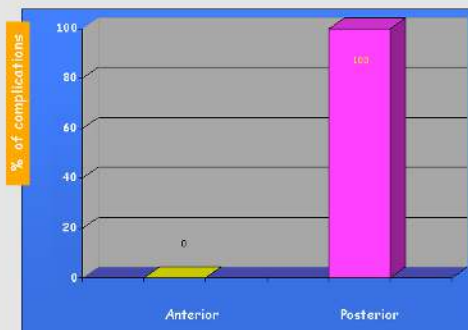
Fig 5 : Distribution of the complications. All complications occurred in the posterior region.

was recorded in the anterior region (fig 5) and for any screw-retained prosthesis (fig 6). 2.9% of the single molars had a prosthetic complication. The cumulative ITI prosthetic components success rate was 97.97 %.

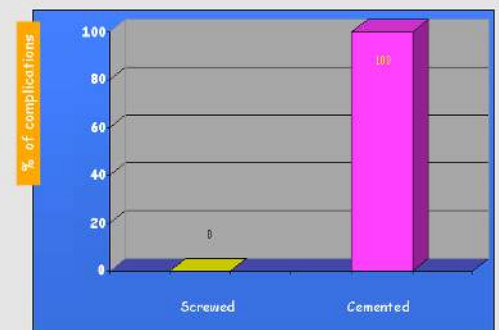
Fig 6 : Distribution of the complications. All complications occurred for the cemented restorations.

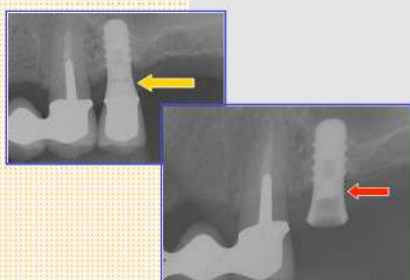
Fig 7 : Abutment fracture. The fracture seen on the X-ray (arrow). The fractured portion remained in the implant (red arrow).

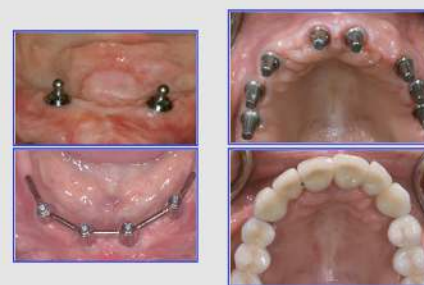
Fig 8 : Edentulous patient rehabilitation. 2 spheric anchorages, a bar for an overdenture or a full-arch fixed prosthesis on 8 implants.

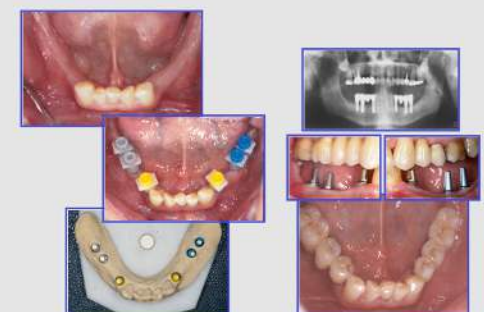
Fig 9 : Partially edentulous patient rehabilitation. The various stages of the treatment are shown, until completion of the bridges.
